NUMBER: 08-025-20

DATE: March 3, 2020

RAN RAP RAJ RAG and RSD Radio Software Enhancements

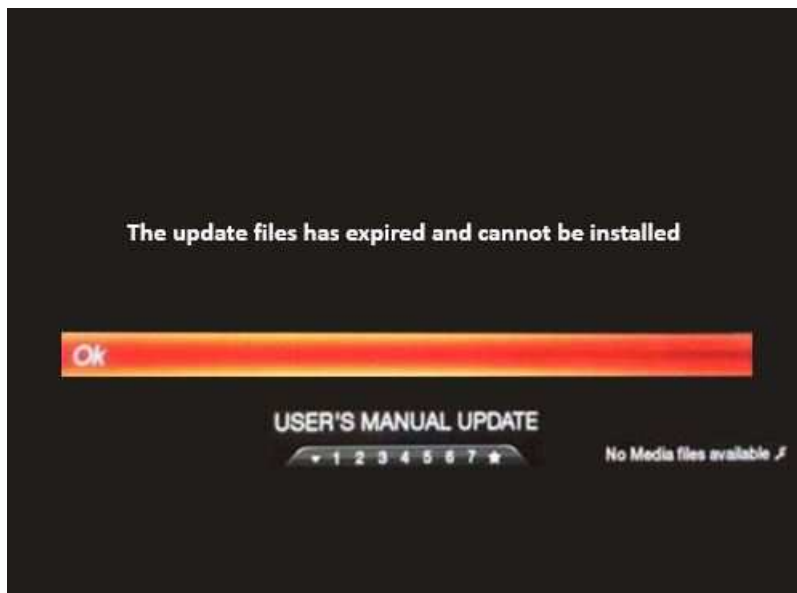
Fig. 1
Update File Error Prompt

Some technicians may experience an error when they attempt to update the User Guide. The radio may prompt an error, "The update file has expired and cannot be installed" (Fig. 1) .

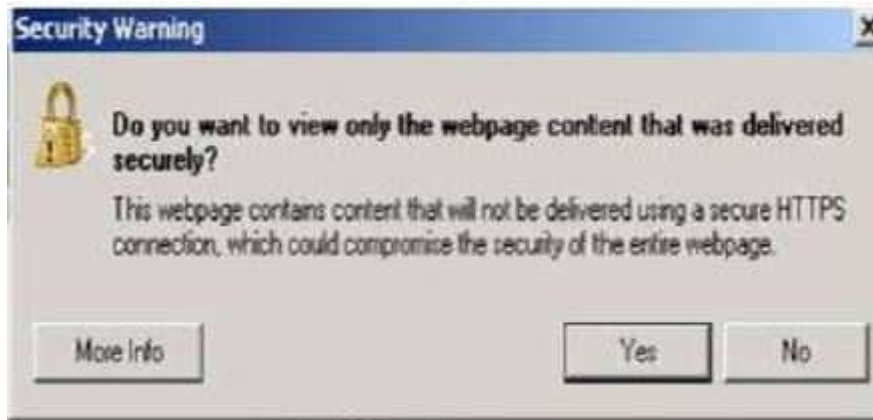
Fig. 2
Security Warning Pop-up

2. Go to DealerCONNECT> Service> UCONNECT Command Center> Uconnect> Dealer software downloads, to download the files.
3. If a security message appears “Do you want to view only the webpage content that was delivered securely?” ([Fig. 2](#)) . Press “No” to continue.

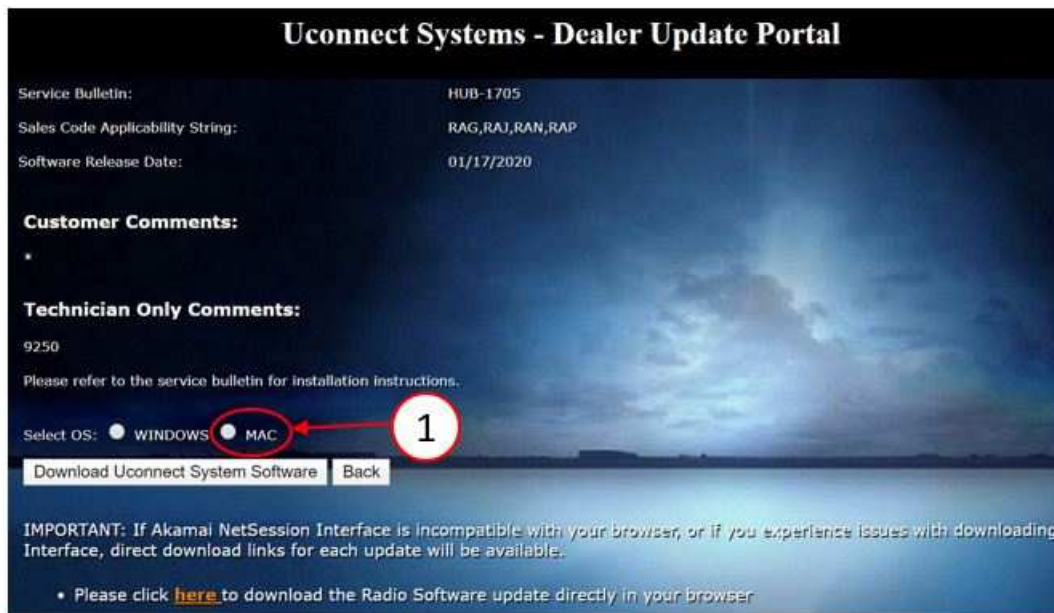
Fig. 3
Uconnect Update Portal

- Download the software update files to your local PC's desktop. Make sure to select the "MAC" for 2D and 3D Navigation downloads only (Fig. 3) .

1 - Select the "MAC" for 2D and 3D Navigation only

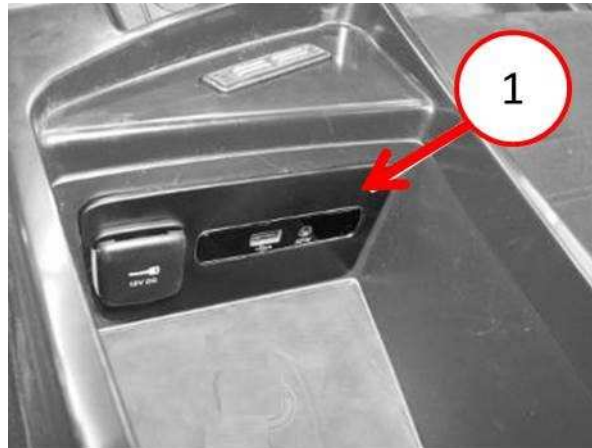
Fig. 4
Location of the USB Port

10. Insert the USB flash drive with the Map updates in the port below the center console armrest, (Fig. 4) .

1 - USB Port
