NUMBER: R08 FSAR-NSB-7916

GROUP: 08 - Electrical

Enable Android Auto and Apple CarPlay

2018 (GA) Alfa Romeo Giulia

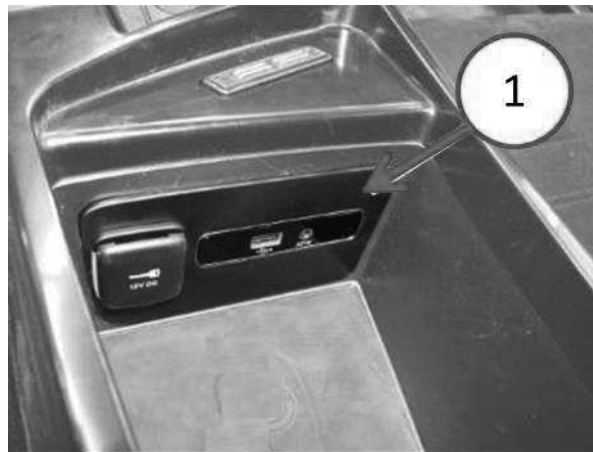
Fig. 1
Location of the Media Hub

1 - Media Hub

1. Replace the Media Hub in the center console. Refer to the detailed service procedures available in DealerCONNECT> TechCONNECT under: 08 - Electrical/8A - Audio/Video/Entertainment/Connectivity/Media Hub/Removal and Installation. See (Fig. 1) for the location of the Media Hub.
