NUMBER: 08-045-20 REV. A

Body Control Module (BCM) Reconfigure for Forward Collision Warning (FCW)

2020	(GA)	Alfa Romeo Giulia
2020	(GU)	Alfa Romeo Stelvio

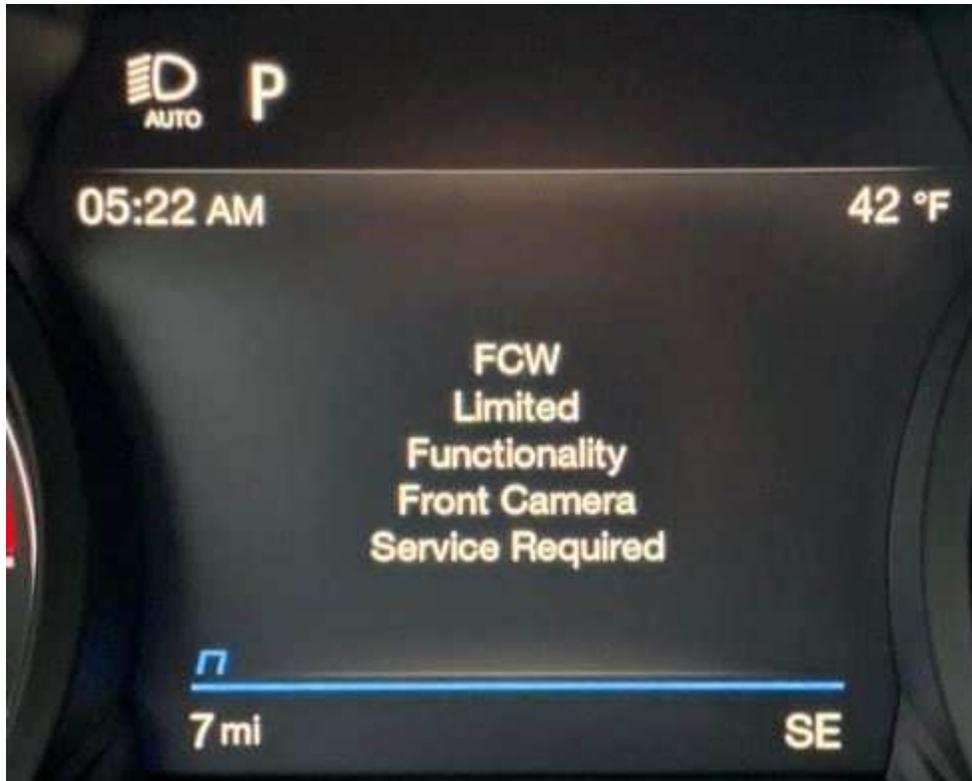
- The Electronic Vehicle Information Center (EVIC) displays "Forward Collision Warning (FCW) Limited Functionality Front Camera Service Required" (Fig. 1) .

Fig. 1
EVIC FCW Message

1. Using the scan tool (wiTECH 2), perform a "Restore Vehicle Configuration".
2. Perform a "Proxi Configuration Alignment".
3. DTCs will still be active. Cycle the ignition off, the back on and the codes should change from "Active" to "Stored".
4. Clear all DTCs that may have been set.
5. Remove the Micro Pod from the vehicle.
6. Cycle the ignition off, exit the vehicle, lock the doors and let the vehicle sleep for 10-15 minutes (**keep the FOBs away from the vehicle to ensure them from waking up the bus**).
7. Place the ignition in the "On" position and connect the (wiTECH 2). Verify the codes have not returned. If codes have returned then perform normal diagnosis.
