# NHTSA Recall 4404/50

<p>Group 40 File 1          Campaign 4404/50          Subject HEADLIGHT WIRING          MODIFICATION          Date MAY 12, 1988</p>
---	---	---

**RECALL CAMPAIGN NO. 4404/50  
 1987-88 ALFA ROMEO MILANOS  
HEADLIGHT WIRING MODIFICATION**

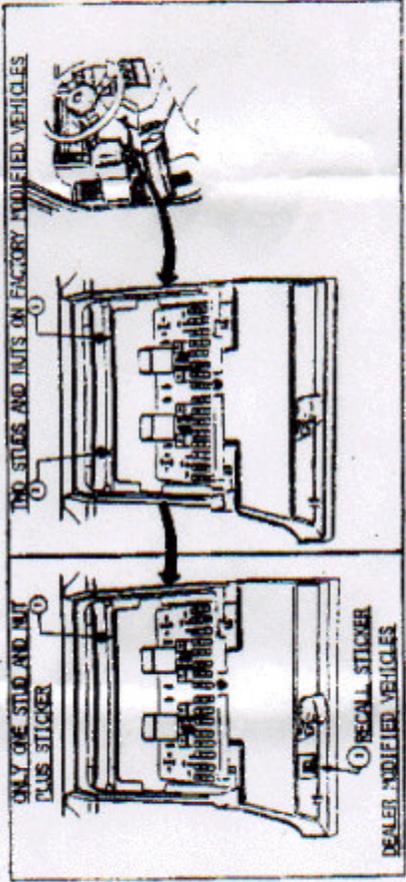
VEHICLES WHICH DO NOT NEED HEADLAMP MODIFICATION

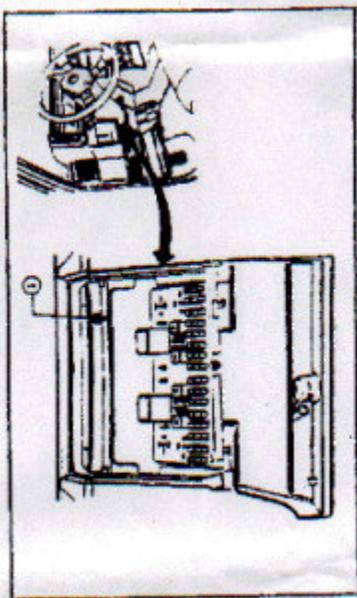
VEHICLES WHICH MUST HAVE RECALL PERFORMED

ONLY ONE STUD AND NUT

AND

NO RECALL STICKERS

- A. Replacing the terminal connector of the power feed wire to the headlamp switch with a superior design, phosphorus-bronze plated, female spade connector.
- B. Thorough inspection of the headlamp switch in the power feed terminal area to detect any deformation of the switch body, replace switch if necessary.
- C. Installing a relay to carry power to the low beam headlamps to reduce the load on the headlamp switch power feed terminal.
